Manhole Inspection Summary

Manhole # S31II_017MH

Location Address: **1401 MOSHER ST**

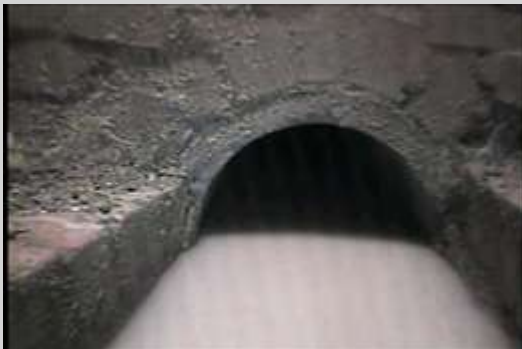
8 in. Circular Gravity Sewer Pipe In @ 6 O'Clock

Rod and Bar (Angled)

Infiltration: **None** Pipe Seal Cond: **Unknown**
